Report on the investigation of heavy weather  
encountered by the cruise ship

***Pacific Sun***

on 30 July 2008

**Report No 14/2009**  
**June 2009**

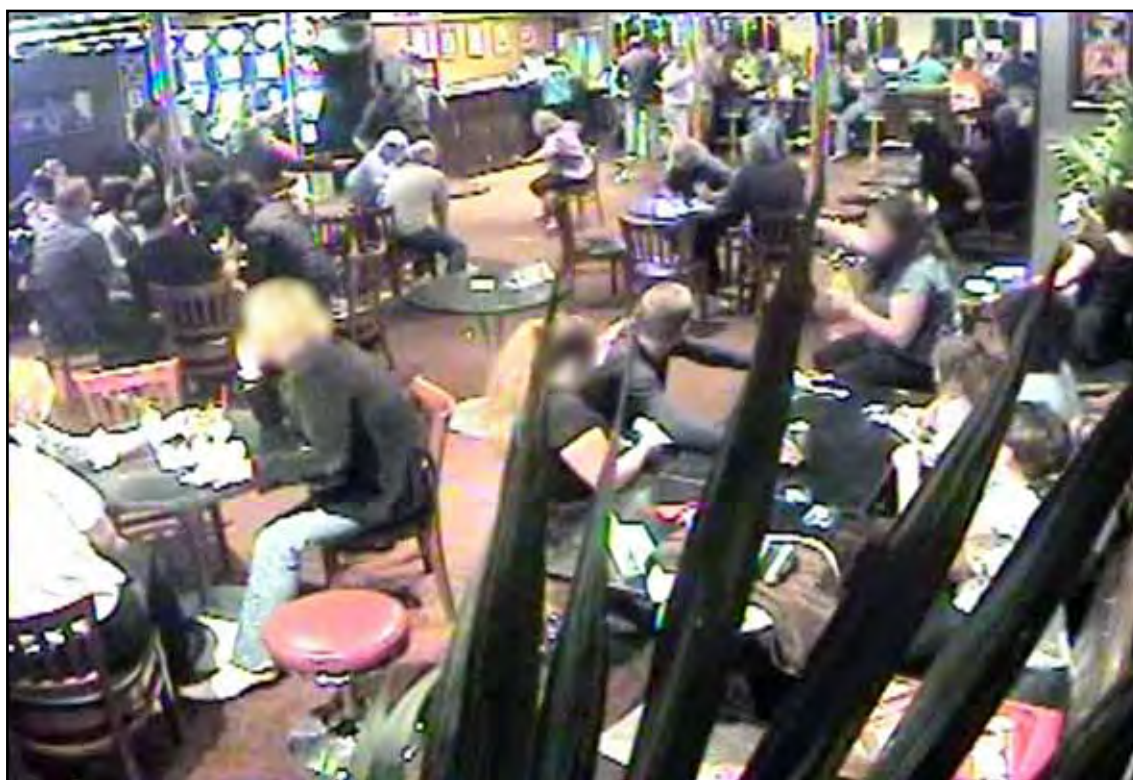
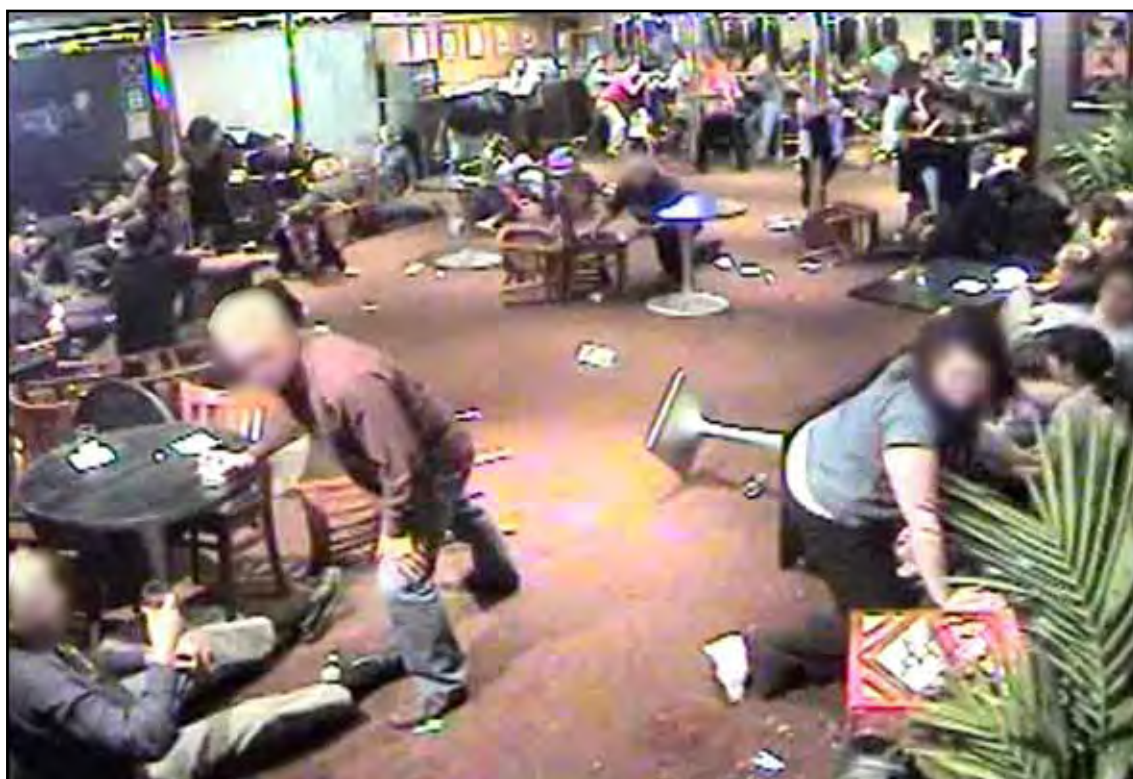
The effect of the roll is shown in the sequence from the CCTV footage in **(Figure 4)**.

Legends Bar, Deck 9, prior to the three large rolls

Legends Bar, Deck 9, following the three large rolls

In the Legends Bar, where bar service was being provided, the effect of the roll can be seen in the 'before' and 'after' pictures at **Figure 4**. The settees, tables and chairs were all able to move freely, and the CCTV footage showed passengers attempting to regain their balance by grabbing at heavy unsecured tables and other unsecured furnishings as they were thrown and fell across the deck. The broken glass, liquids and fallen plant pots added to the hazards the passengers and crew faced, and at least seven injuries were reported from this area.

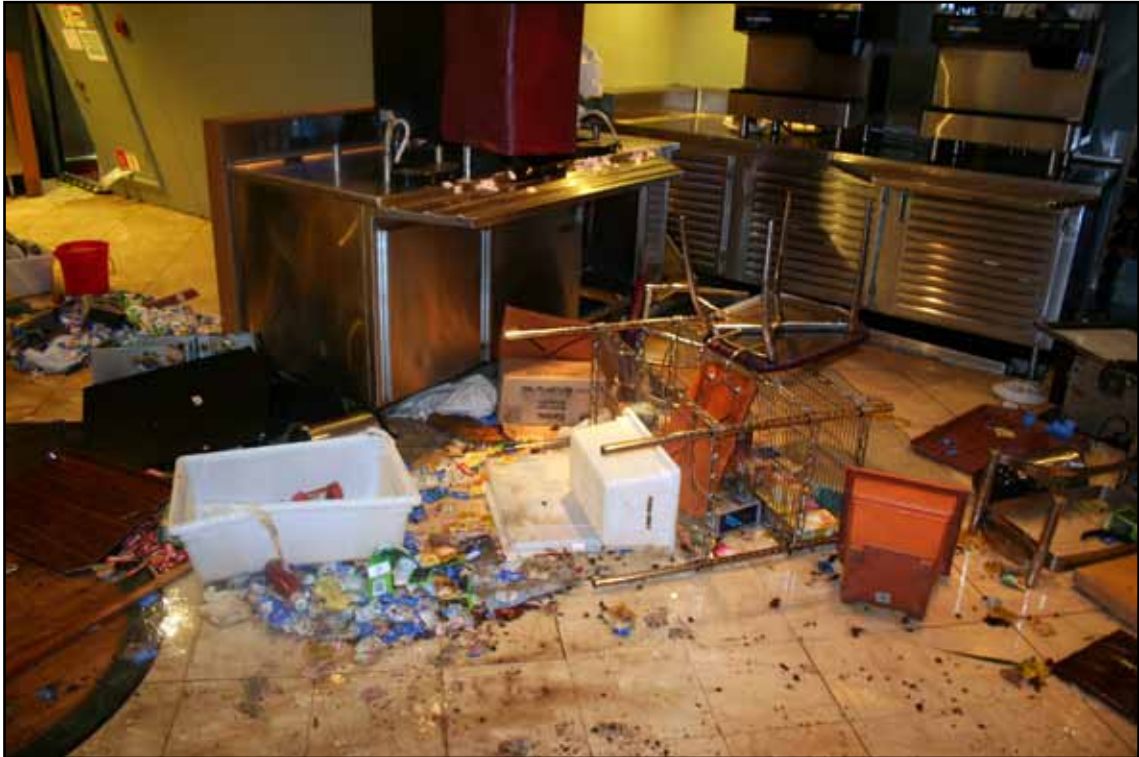
Figure 5a

Public rooms condition following the accident - Outlook Bar and Grill,  
Deck 10, Muster Station C

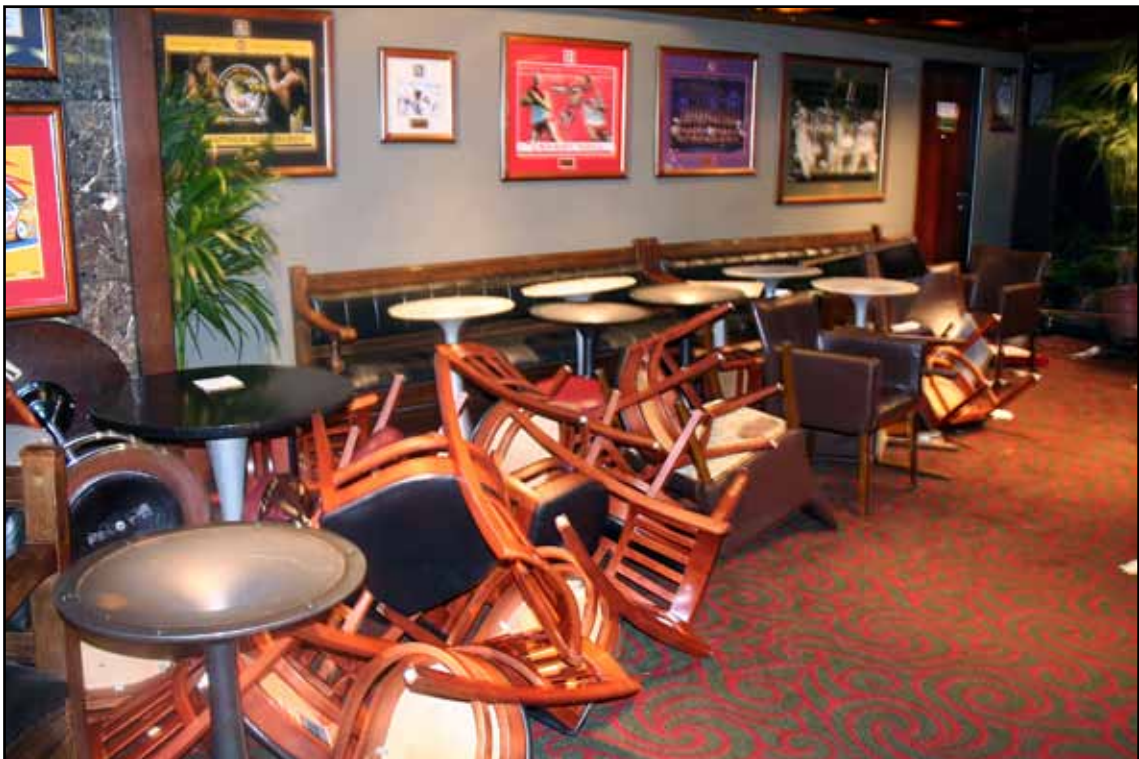
Figure 5b

Legends Bar, Deck 9, Muster Station B

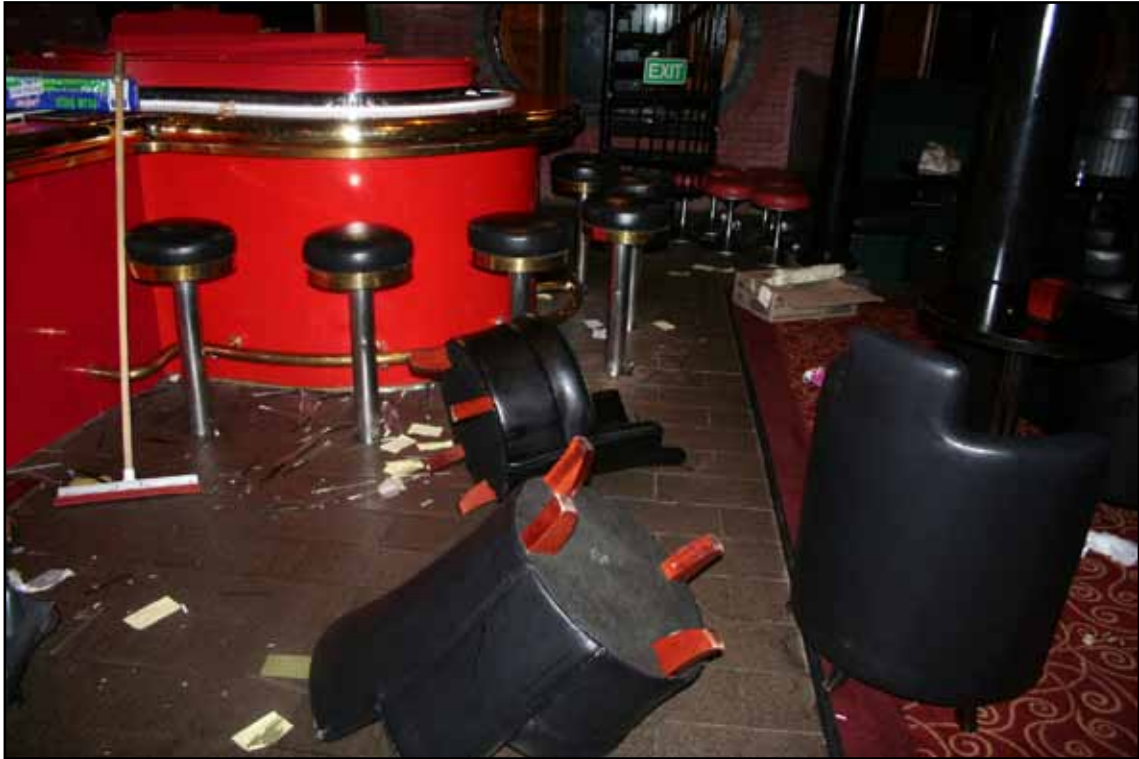
Figure 5c

Speak Easy Piano Bar, Deck 8

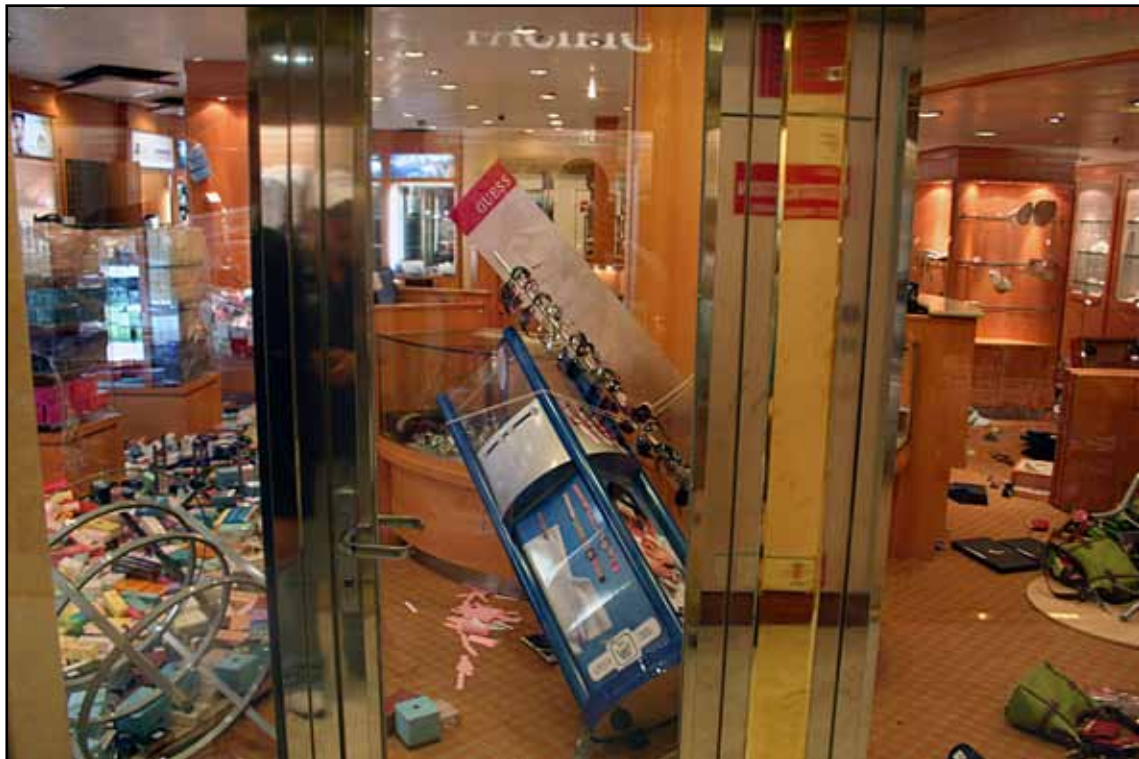
Figure 5d

Duty-free shop, Deck 8

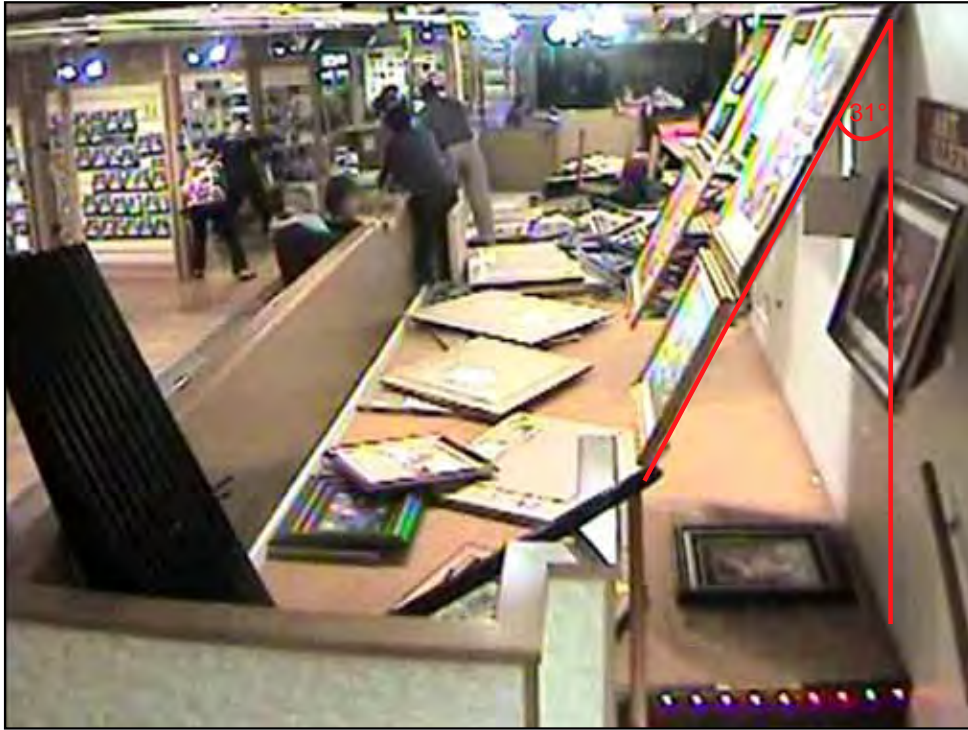
Art Gallery and Photo Gallery, Deck 9, at the largest recorded roll angle

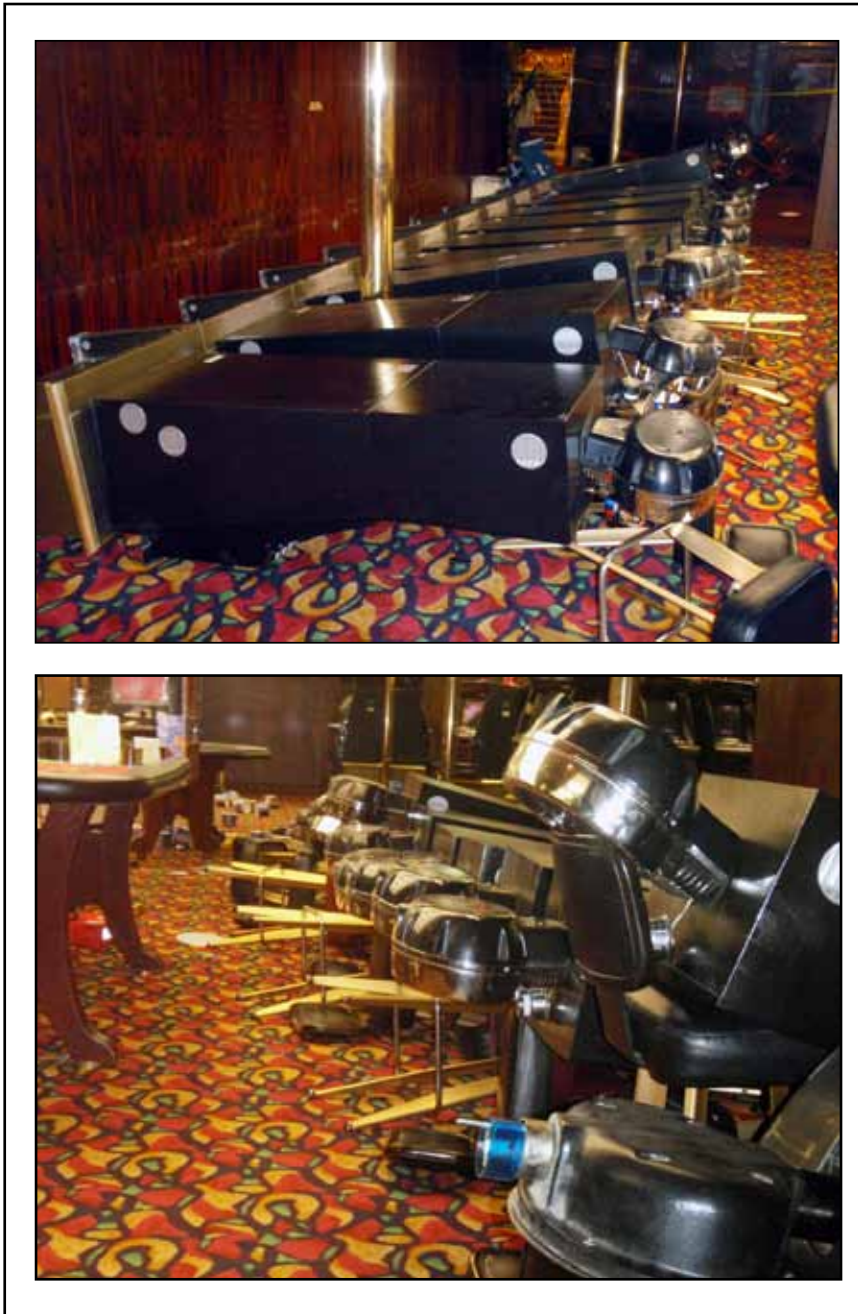
Figure 9

This muster station combined two areas of deck 9. The effect of the rolling in the casino area caused large secured items to move, including a bank of gaming machines to fall from the bulkhead (**Figure 9**). Some passengers only avoided injury because the adjacent chairs prevented the gaming machines from collapsing directly on to the deck. The electronic poker machine (**Figure 10**) came adrift and travelled across the casino deck, causing several reported injuries.

Collapsed casino gaming machines, Casino, Deck 9

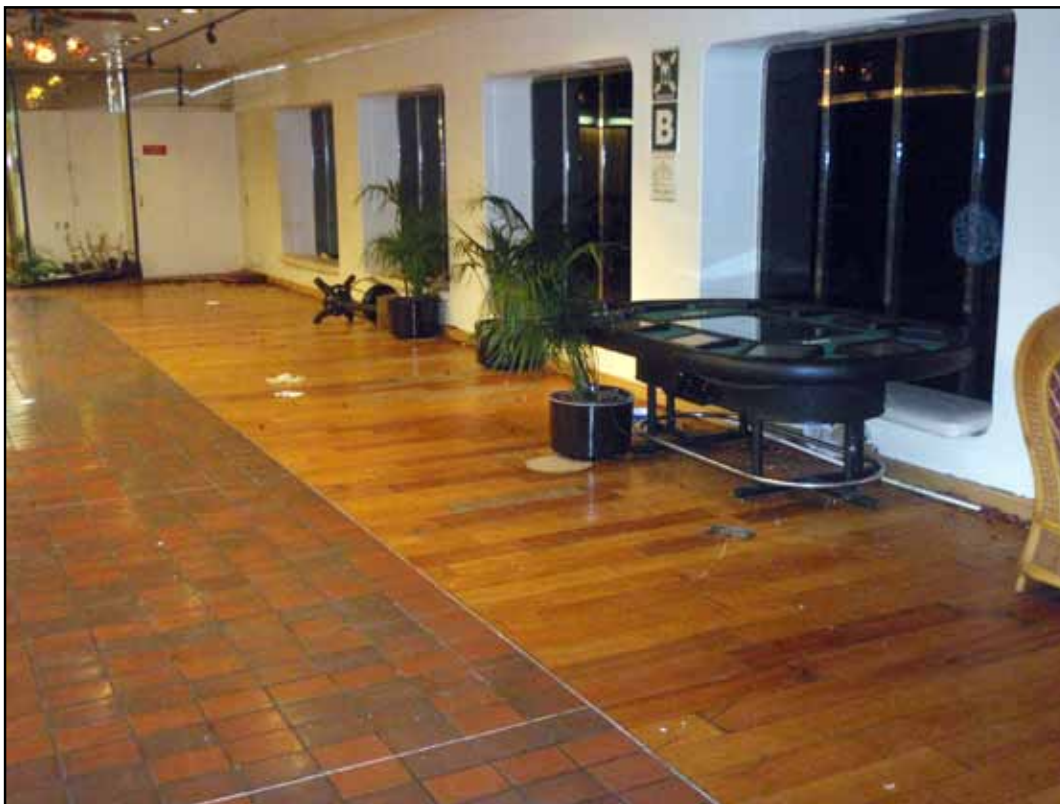
Poker Pro machine, released from mountings, Deck 9

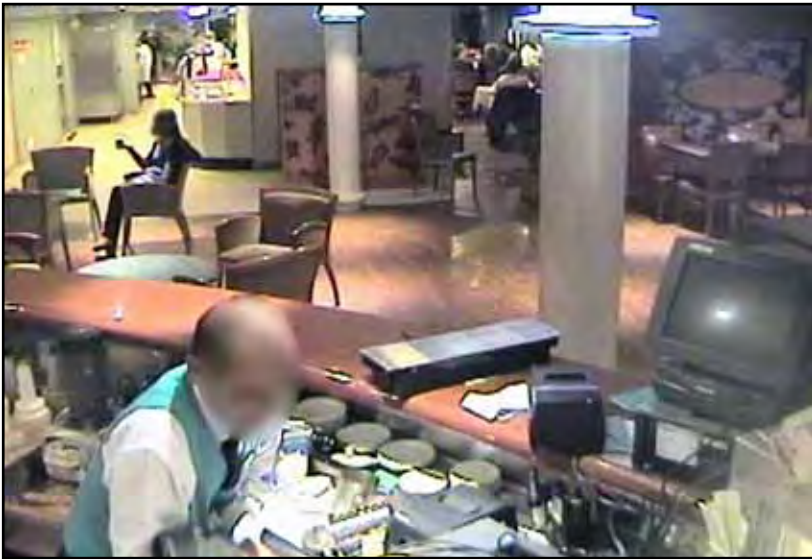
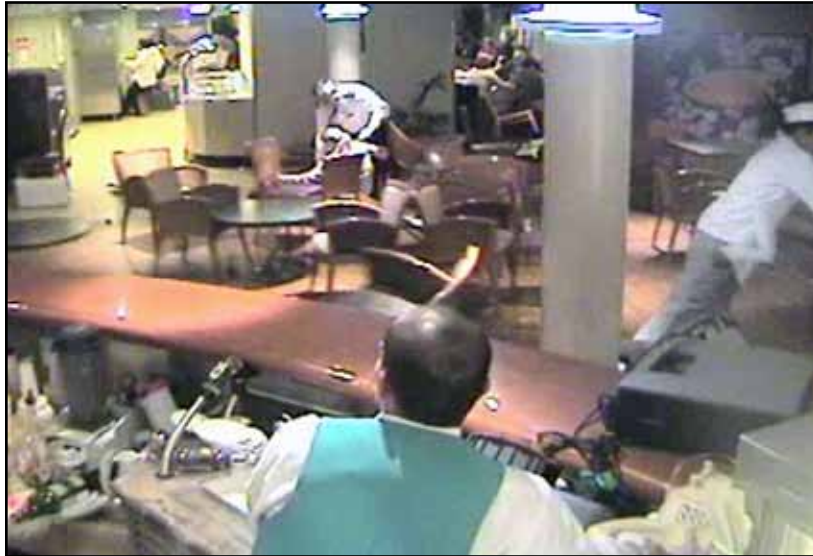
Outlook Bar and Grill - Deck 10, Muster Station C, during the large rolls

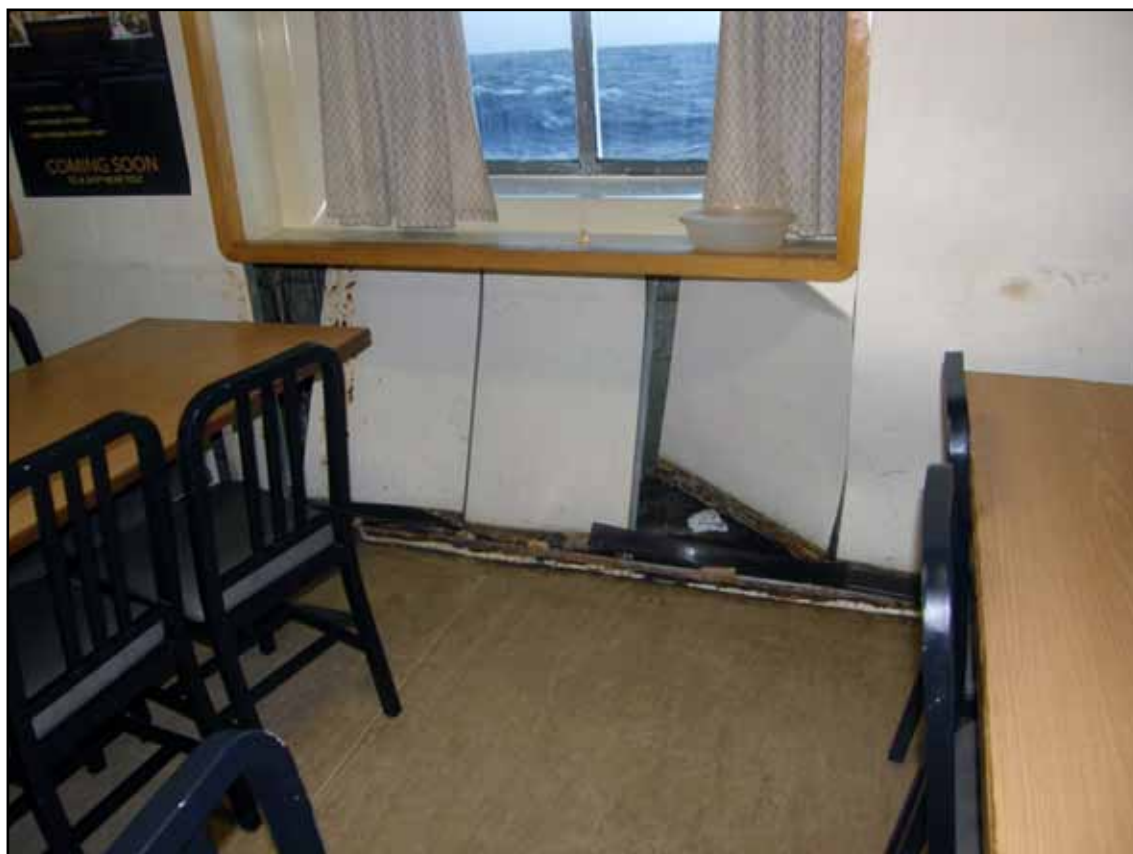
Figure 12

In the officers, staff and crew mess rooms (**Figure 12**), all of which were in use at the time of the accident, no tables or chairs were secured to the deck and all of these moved as the ship rolled.

Damage to crew mess room, Deck 3

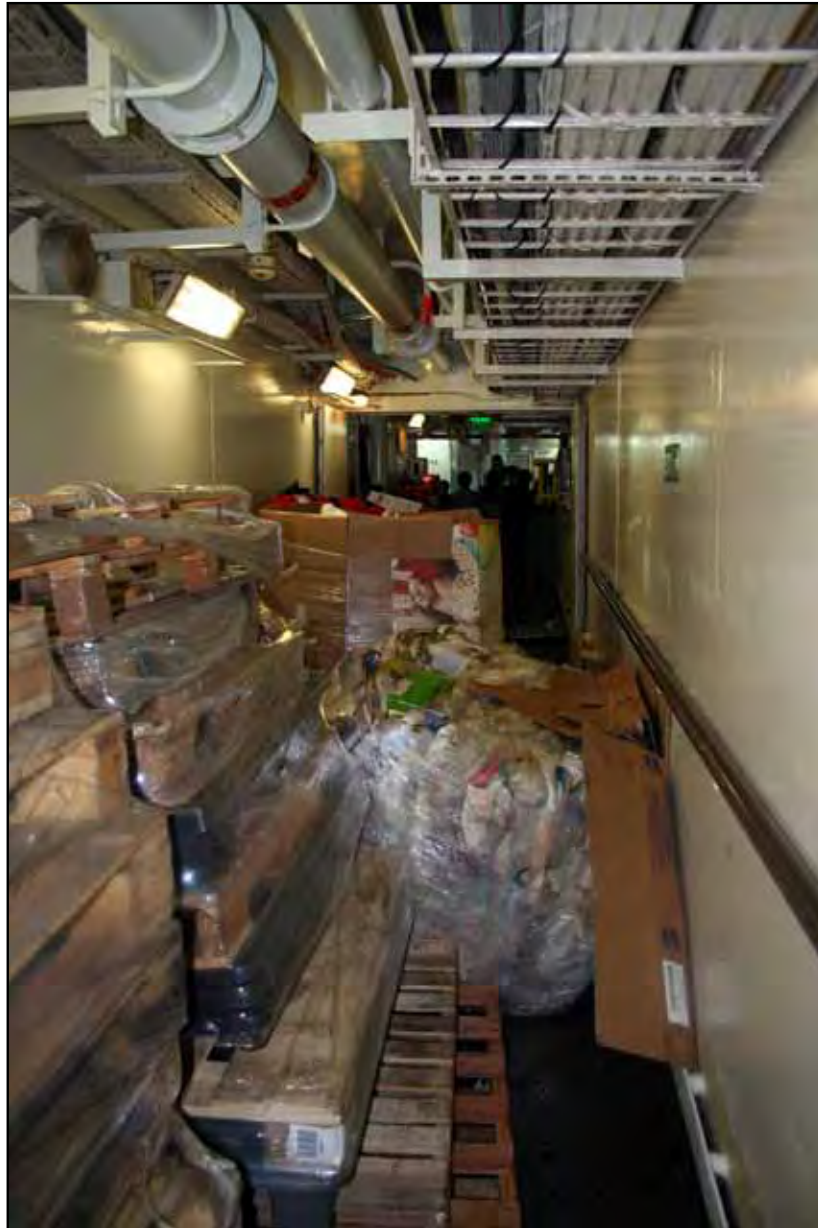
Figure 14

In preparation for arrival in Auckland the next day, the crew had started to place on deck 3 the garbage and other equipment for landing, and some of these stows collapsed, blocking alleyways (**Figure 14**).

Deck 3 - main crew alleyway after accident

Under normal conditions, the preferred route to the medical centre from the forward part of the ship for stretcher parties was via the main crew alleyway. However, the obstructions in the store handling area and main crew alleyway on deck 3, along with the wet decks, made passage through this area extremely difficult.

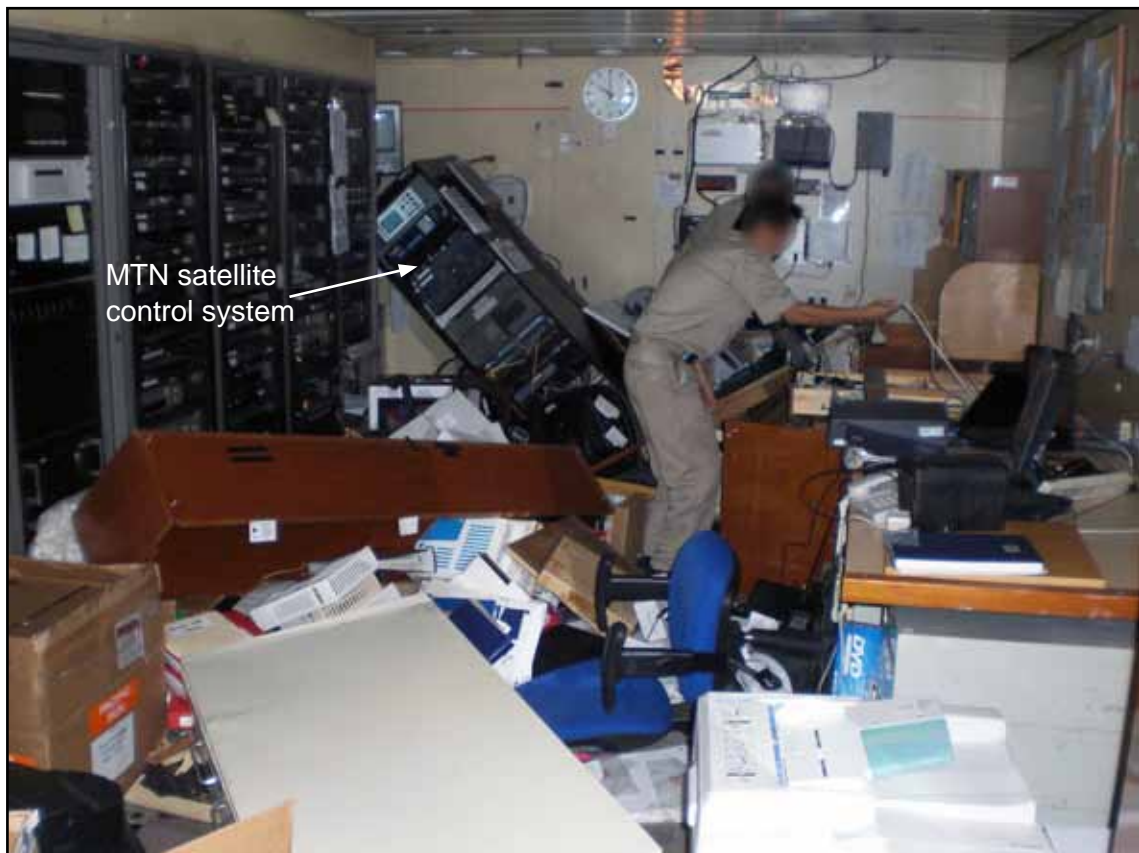
Figure 15

As the vessel rolled, the MTN<sup>4</sup> satellite communications system in the communications office on deck 11 ripped from its securing arrangement and fell over, tearing out connections and disabling the unit (**Figure 15**).

Electro Technical Office after the accident

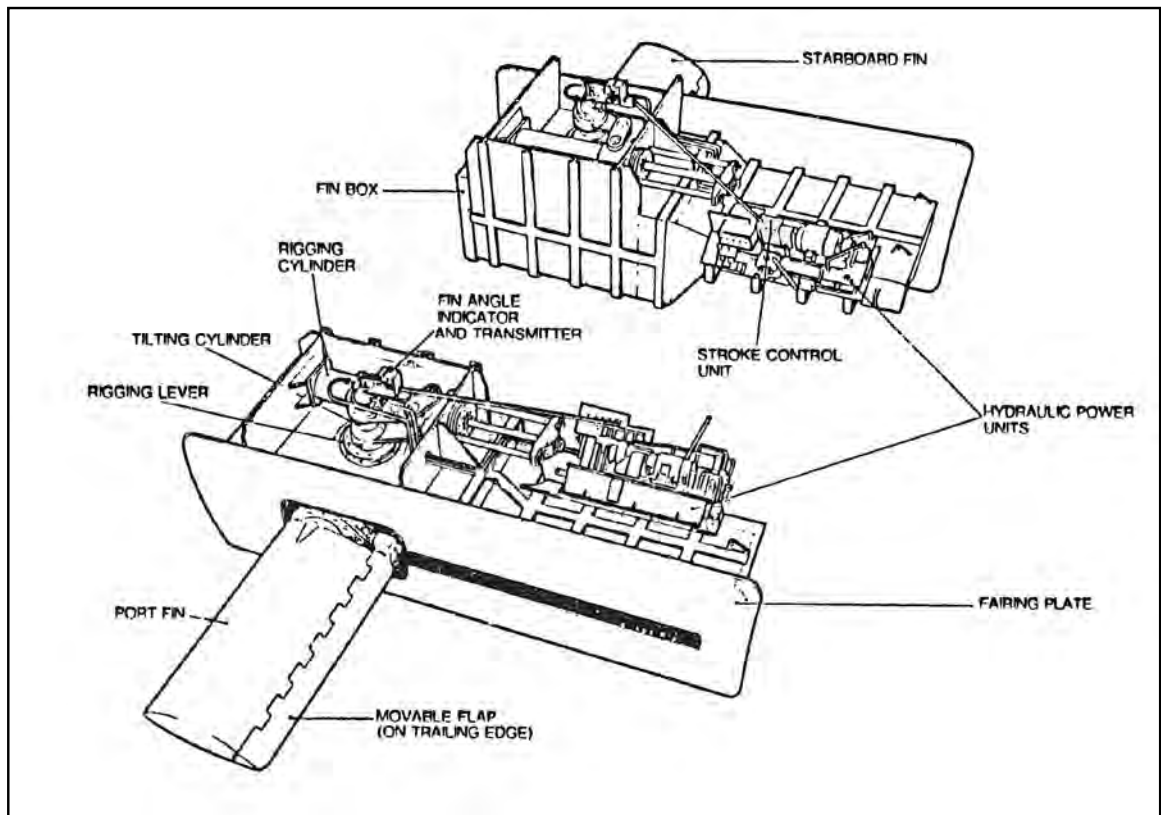
Figure 17

Typical stabiliser machinery unit as fitted to *Pacific Sun*

*Pacific Sun's* port stabiliser was inoperative because parts of the system were heavily worn and could not be replaced until the next period in dry dock. Her starboard stabiliser was operating in angle control mode due to a failure of the lift transducers required for the lift control mode. This was caused by salt water entering the transducer compartment. An overhaul of both the stabilisers had been scheduled for the vessel's previous dry dock maintenance period, in Brisbane in 2004. However, Brisbane's dry dock was insufficiently wide for the stabilisers to be withdrawn, and the overhaul was postponed to the forthcoming 2008 dry dock.
