Report on the investigation of heavy weather  
encountered by the cruise ship

***Pacific Sun***

on 30 July 2008

**Report No 14/2009**  
**June 2009**

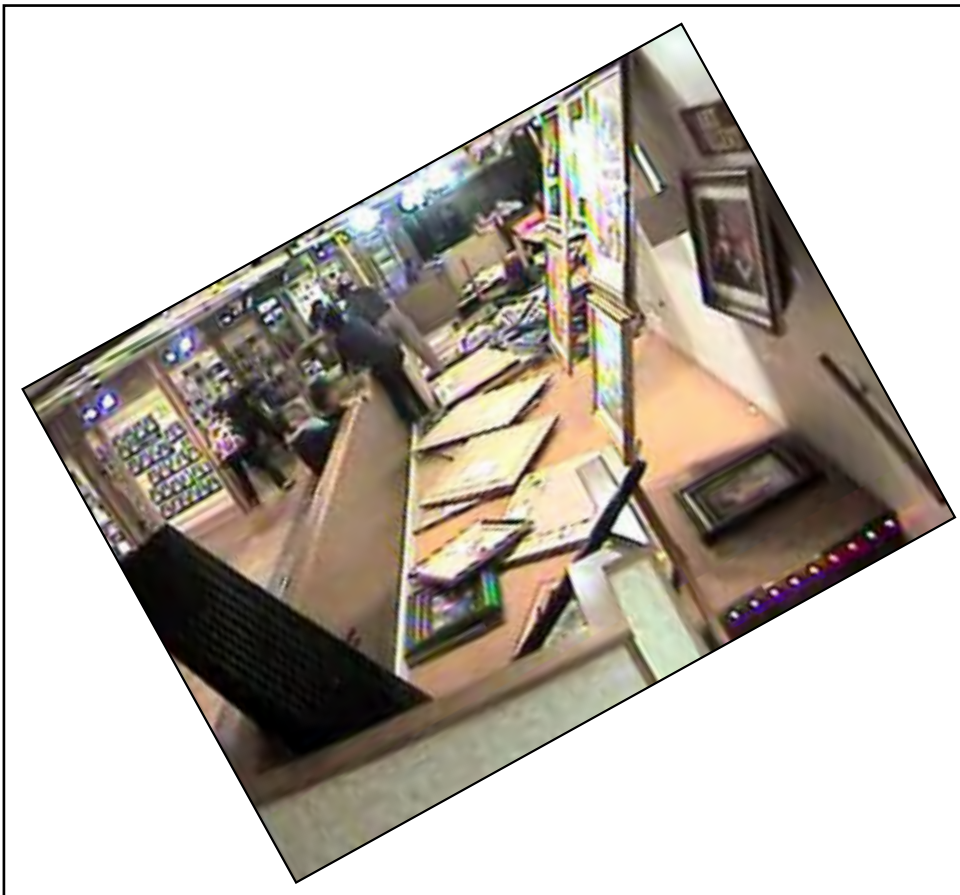
How the vessel would have appeared at 31°

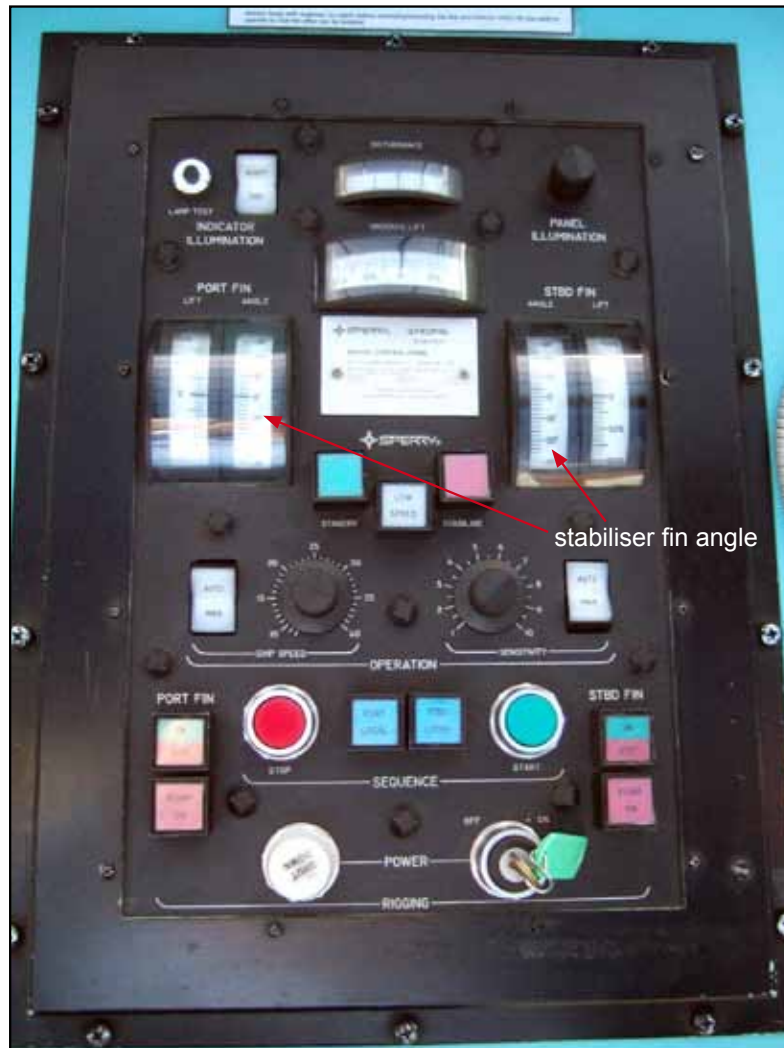
Bridge Gyrofin control unit

*Pacific Sun's* port stabiliser was inoperative because parts of the system were heavily worn and could not be replaced until the next period in dry dock. Her starboard stabiliser was operating in angle control mode due to a failure of the lift transducers required for the lift control mode. This was caused by salt water entering the transducer compartment. An overhaul of both the stabilisers had been scheduled for the vessel's previous dry dock maintenance period, in Brisbane in 2004. However, Brisbane's dry dock was insufficiently wide for the stabilisers to be withdrawn, and the overhaul was postponed to the forthcoming 2008 dry dock.
